Field Report for Airborne Data Collected In Support of US EPA Region 6 South 4 Group Fire 06 December 2019

Flight Results for Flight 18, 06 December 2019

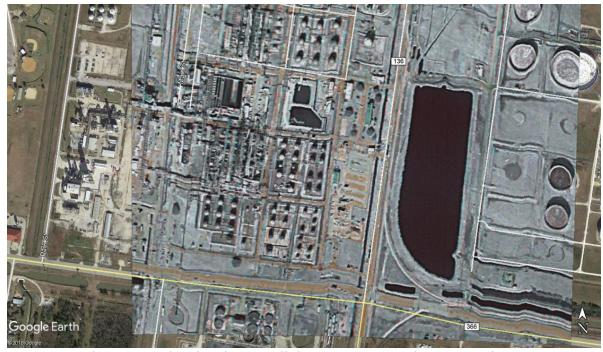
Figure 3: – 3 band IR image, Flight 18, Run 7, South 4 Group Fire

A total of 1 test and 9 data collection passes were made in the proximity of the facility and an infrared line scanner image was generated for each pass. Figure 3 shows a typical 3-band infrared image obtained from data collected for Run 7. Analysis of the image shows a flat thermal environment for the process unit other than isolated locations heated by solar radiation. No plume is present in the image. To assess possible oil sheen presence on the Naches River and a nearby drainage channel, ASPECT collected IR data along the drainage waterways; no oil sheen signatures were detected (figures 4 and 5).

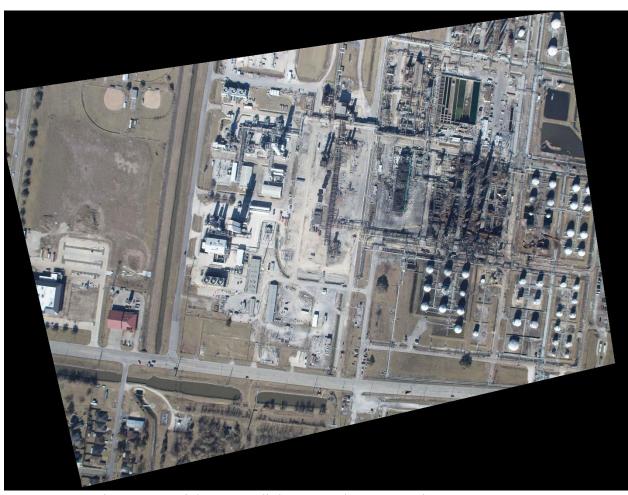
Figure 6: Aerial Image, Flight 18 South 4 Group Fire.

A full set of high resolution aerial digital photography were collected as part of the flight. Figure 6 and 7 show representative views of the process unit. No emissions are visible in these images. In addition, the images and crew reports indicated that no water cannon was in use.
